GROUP
Safety Recall Campaign

NUMBER
SC176 (Rev 4, 07/13/2023)

MODEL
**2012-2016MY
Soul (AM, PS)**

SUBJECT: ENGINE CONTROL UNIT (ECU)
LOGIC IMPROVEMENT (SC176)

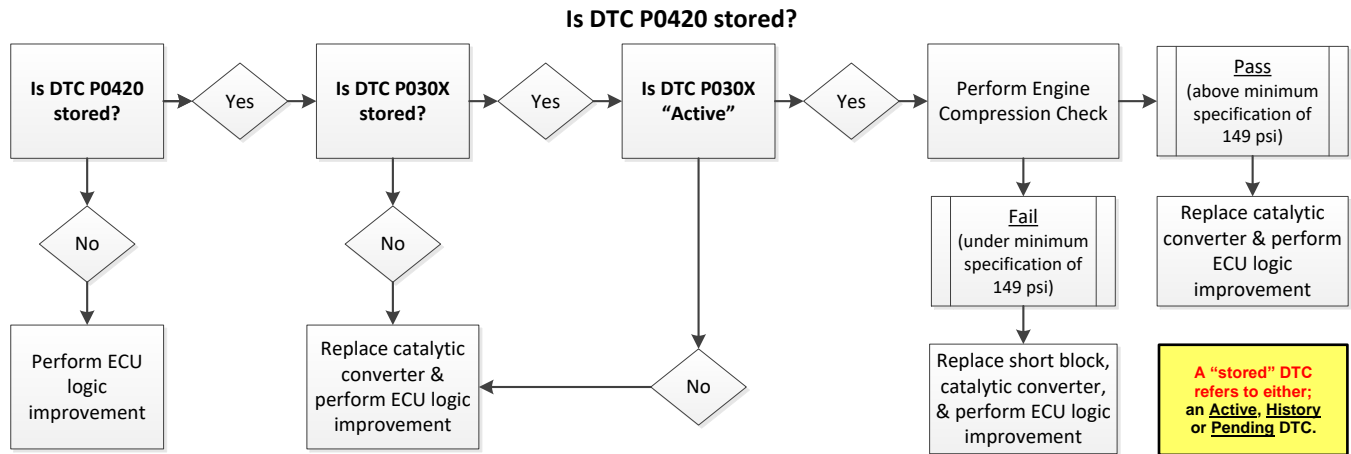
Flow Chart:

- Using the KDS (connected to the internet to create and transmit a VDN*), perform a Fault Code Search and confirm DTC P0420 or both P0420 and P030X is/are **stored (Active, History or Pending)**. Follow the flow chart below and perform the necessary procedure(s).
 *A Vehicle Diagnosis Number (VDN) must be created with DTC P0420 or P0420 and P030X, prior to ordering select parts and performing necessary procedure(s) according to flow chart. If a VDN is not created, Parts order entry or Warranty claim submission issues may occur.

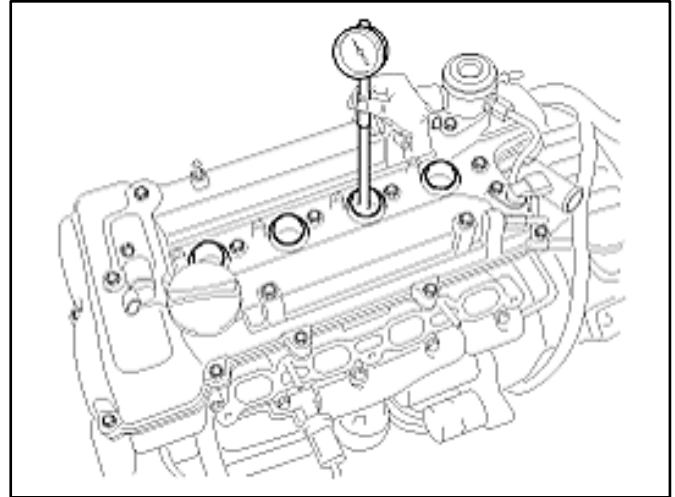
- Coolant at operating temp (176°F)
- Battery fully charged
- If all cylinder compression results* are above the minimum specification, proceed to the Catalytic Converter Assembly Replacement Procedure below.
- If any cylinder compression result* is below the minimum specification, proceed to the Short Block Assembly Replacement Procedure on page 10.

Standard	178 PSI, 1225.83 KPa, 12.5 kg.cm ²
Minimum	149 PSI, 1029.69 KPa, 10.5 kg.cm ²

***Perform all cylinder compression checks twice (2x) and record both peak cranking values clearly and legibly on the repair order.**
