GROUP	MODEL
Safety Recall Campaign	2020-2021MY Soul (SK3) and 2021MY Seltos (SP2) w/2.0L Nu MPI engine
NUMBER	DATE
SC209 (Rev 4, 04/06/2022)	June 2021

### ENGINE VIBRATION INSPECTION AND REPLACEMENT (SC209)

This bulletin provides information to perform an engine vibration inspection and, if necessary, replace the engine long block on some 2020-2021MY Soul (SK3) produced from November 24, 2018 through October 24, 2020 and some 2021MY Seltos (SP2) produced from November 20, 2019 through October 15, 2020 vehicles equipped with 2.0L Nu MPI (Atkinson) Engine. The piston oil rings in the affected vehicles may have been improperly heat-treated during production, resulting in excessive oil ring hardness. Excessive oil ring hardness can lead to chipping of the piston oil ring's outer periphery and scuffing of the engine cylinder bore. A scuffed cylinder bore can lead to increased oil consumption which will eventually result in abnormal noise from the engine and/or illumination of the oil pressure warning lamp. If the vehicle is continually operated in this condition, connecting rod bearing seizure can occur. A seized connecting rod bearing can result in engine damage, thereby increasing t

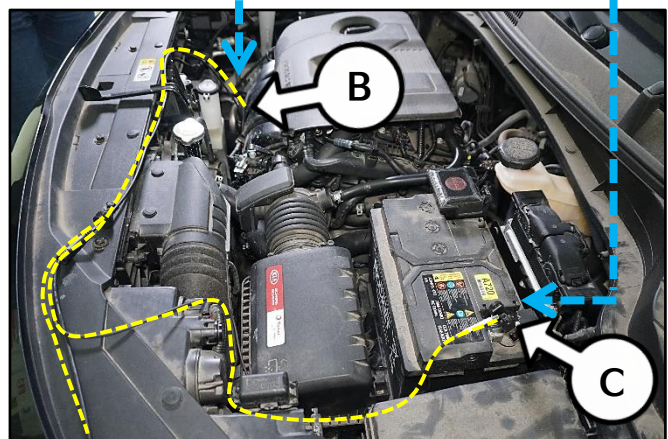
If the vibration inspection harness is placed over the engine components, external vibration may negatively affect to the inspection result. Route the wiring around the engine (yellow outline) shown in the photo.
