GROUP	MODEL
Safety Recall Campaign	2020-2021MY Soul (SK3) and 2021MY Seltos (SP2) w/2.0L Nu MPI engine
NUMBER	DATE
SC209 (Rev 4, 04/06/2022)	June 2021

### ENGINE VIBRATION INSPECTION AND REPLACEMENT (SC209)

This bulletin provides information to perform an engine vibration inspection and, if necessary, replace the engine long block on some 2020-2021MY Soul (SK3) produced from November 24, 2018 through October 24, 2020 and some 2021MY Seltos (SP2) produced from November 20, 2019 through October 15, 2020 vehicles equipped with 2.0L Nu MPI (Atkinson) Engine. The piston oil rings in the affected vehicles may have been improperly heat-treated during production, resulting in excessive oil ring hardness. Excessive oil ring hardness can lead to chipping of the piston oil ring's outer periphery and scuffing of the engine cylinder bore. A scuffed cylinder bore can lead to increased oil consumption which will eventually result in abnormal noise from the engine and/or illumination of the oil pressure warning lamp. If the vehicle is continually operated in this condition, connecting rod bearing seizure can occur. A seized connecting rod bearing can result in engine damage, thereby increasing t

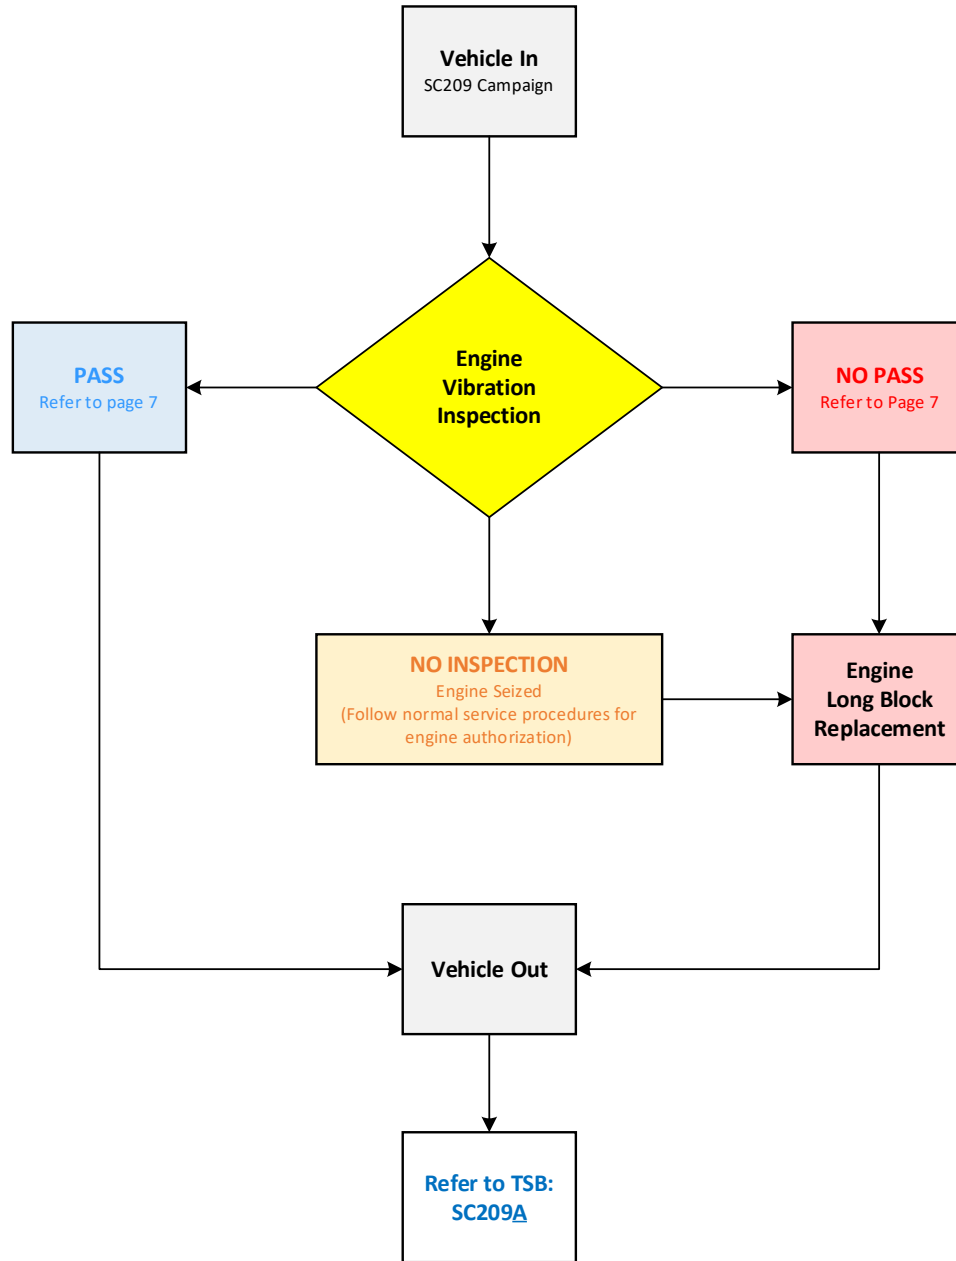
Flowchart:

**PASS (Other Conditions):** If other conditions are present (ex. engine noise) and the Engine Vibration Inspection results in a PASS, then open a Techline case for further instructions.

**RETEST (pg. 8):** If there's an error on the measured engine vibration test, check the jack input (microphone) and knock sensor connection and perform measuring test again. If the results keep displaying 'RETEST' (more than 2 times), open a Techline case online for further instructions.
