GROUP
**Product
Improvement**

MODEL
**2011-2014MY
Optima (QF/TF)
2012-2014MY
Sorento (XMa)
2011-2013MY
Sportage (SL)**

NUMBER
1803 (Rev 6, 07/23/2021)

SUBJECT: **KNOCK SENSOR DETECTION SYSTEM - ECU
LOGIC IMPROVEMENT (PI1803)**

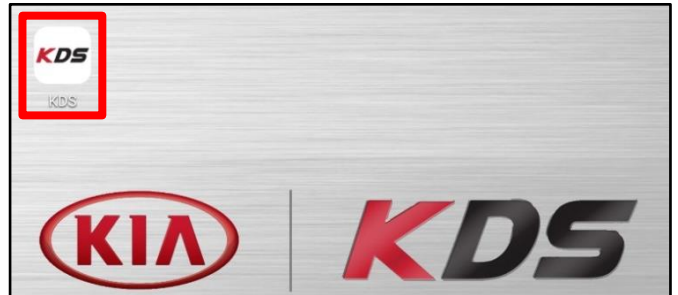
2. With the ignition ON, turn ON the KDS tablet. Select **KDS** from the home screen.
