MODEL
**2014-2016MY
Soul (PS)
w/Nu 2.0L GDI**

NUMBER
2002B (Rev 2, 01/21/2021)

PRODUCT IMPROVEMENT CAMPAIGN

**NU 2.0L GDI - KNOCK SENSOR DETECTION SYSTEM
(KSDS) ECU UPGRADE (PI2002B)**

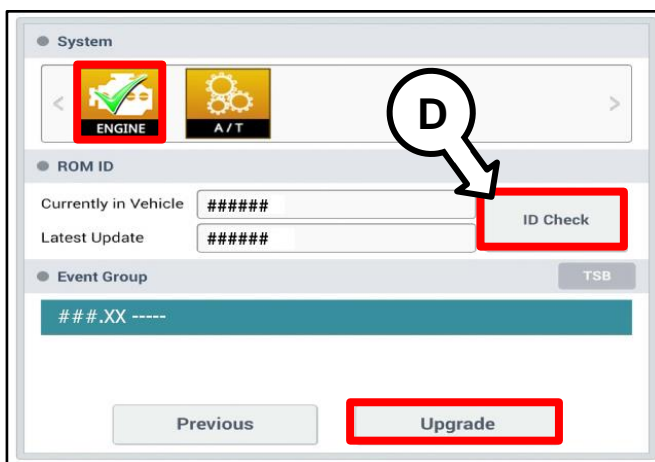
- The ECU upgrade will begin and the progress of the upgrade will appear on the bar graph. Upgrade part (1/2) (E) will download the upgrade event to the VCI-II. Upgrade part (2/2) (F) will upgrade the ECU.

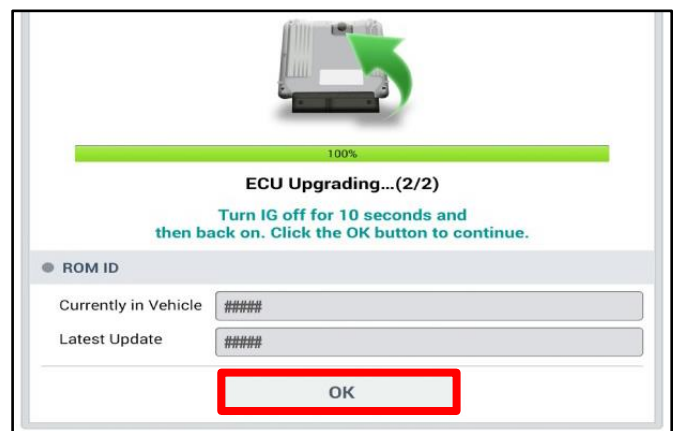
11. Once the upgrade is complete, touch **OK** to finalize the procedure.

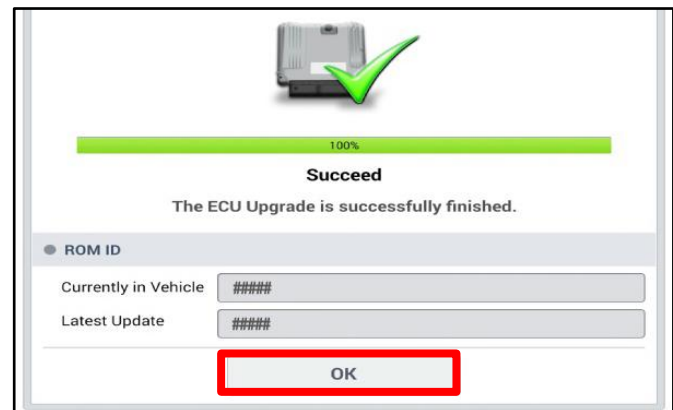
12. When prompted, select **YES** to check for Diagnostic Trouble Codes (DTC) and erase any DTCs stored such as EPS, ESC, and TPMS that may have been set during the upgrade.
